## New Building Inspection Report - Lockup Stage

New Building Inspection Report - Lockup Stage

Dwelling Type:	Freestanding House	Domestic
Dwelling Configuration:	Single Storey	
External Walling:	Other	
Internal Walling:	Plasterboard	
Windows:	Aluminium	
Piers:	-	
Footing Type:	Concrete Slab	
Roof:	Tile	
Image of property:

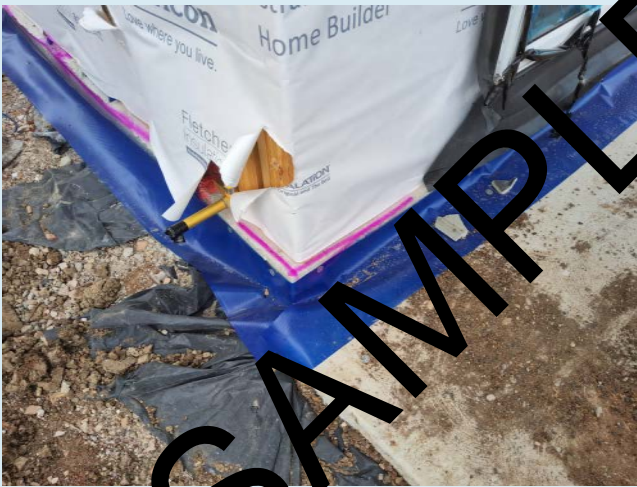
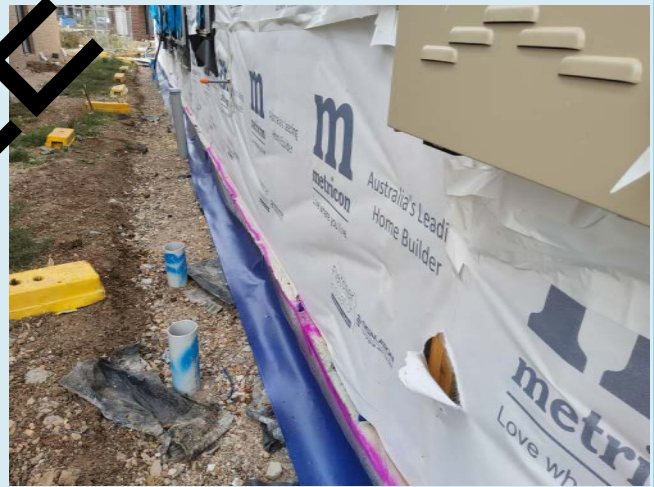
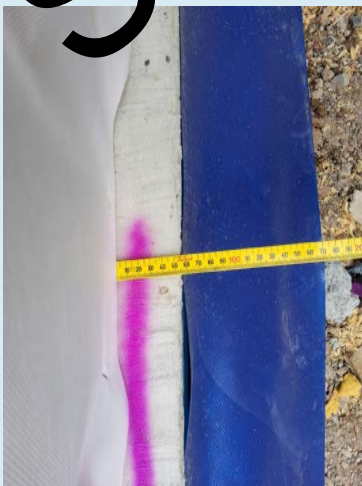
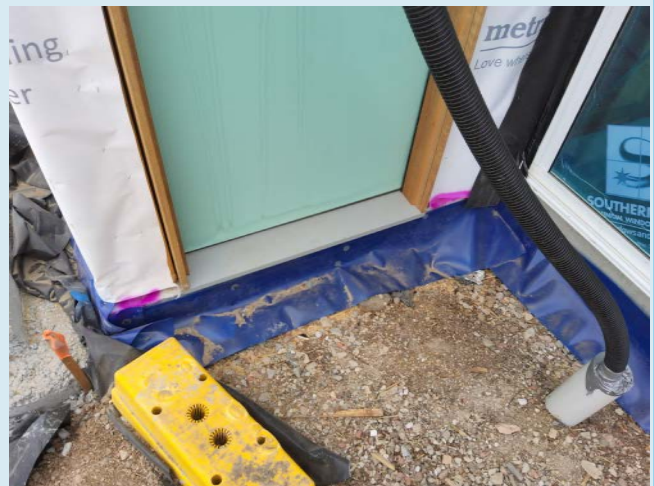
Front, left and rear of garage elevations, it is noted that there appears to be excessive slab overhang, this will need to be cut back, if the reinforcing fabric for the slab is exposed this will also need to be treated to prevent rusting.

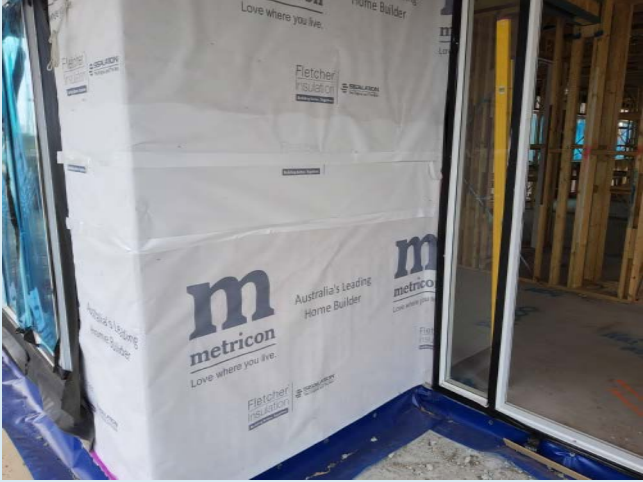
<b>External of house inspection</b>	
<b>Incomplete Item</b>	<b>External Walls</b>
<b>Comments</b>	
It is noted that the Hebel was not yet installed at the time of the inspection.

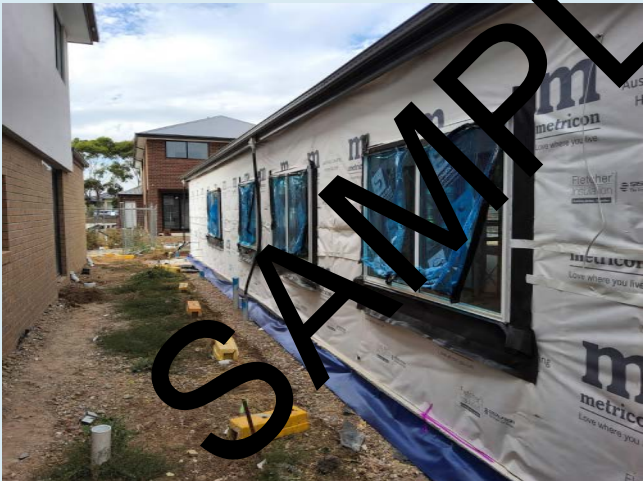
<b>External of house inspection</b>	
<b>Incomplete Item</b>	<b>Downpipes</b>
<b>Comments</b>	
It is noted that only the temporary downpipes were installed at the time of the inspection.

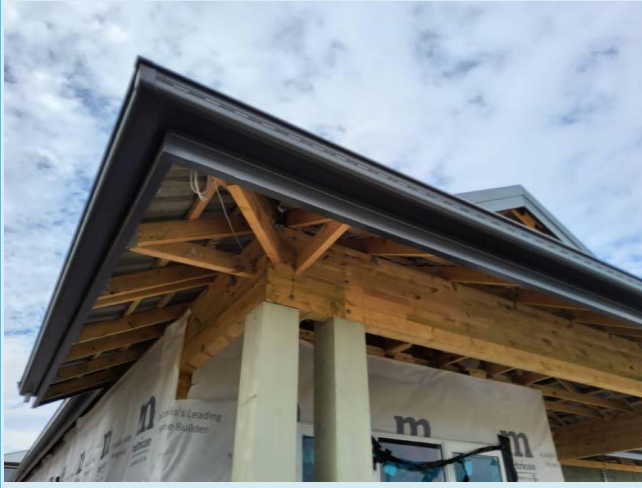
<b>External of house inspection</b>	
<b>Incomplete Item</b>	<b>Eaves</b>
<b>Comments</b>	
It is noted that the eaves were not yet completed at the time of the inspection.

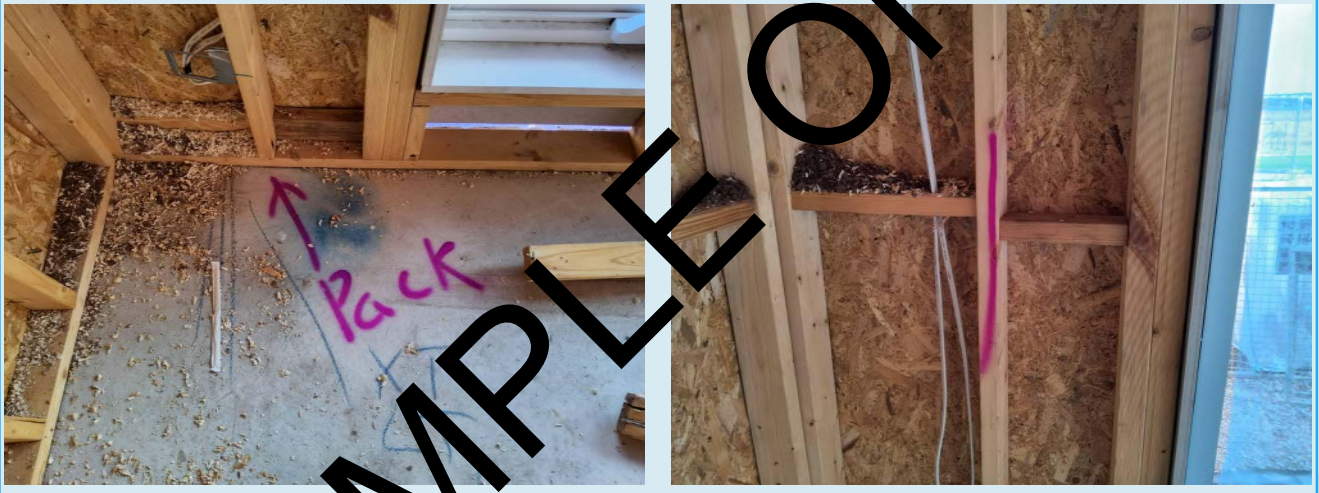
Internal of house inspection	
Minor and/or Major Defect	Internal Walls
Comments	
Living, front elevation left hand side, it is noted that the wall requires straightening.

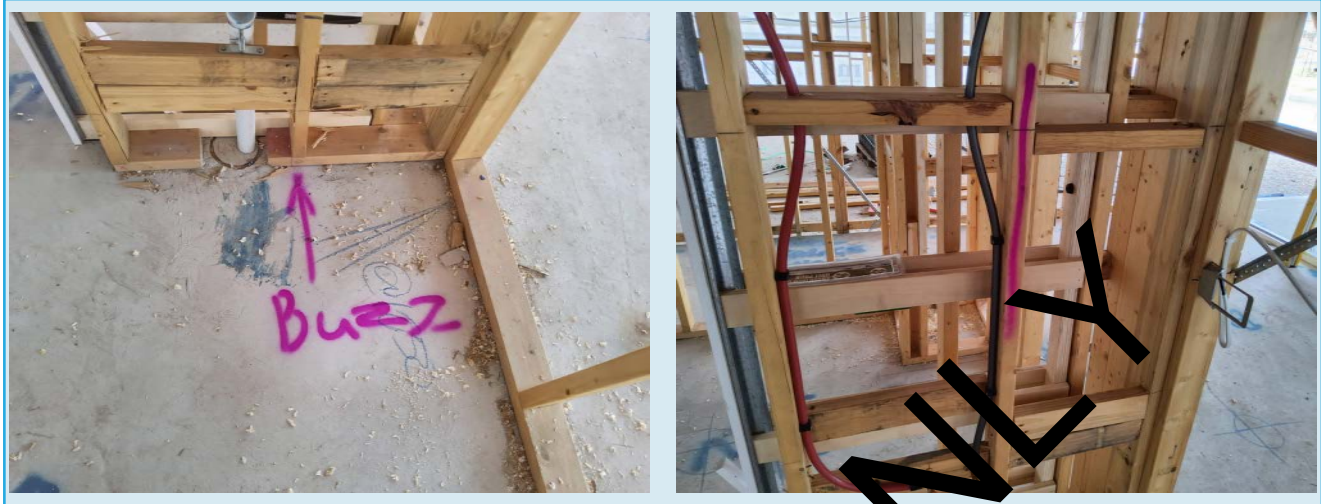
Ensuite 2, right elevation right hand side, it is noted that the wall requires straightening.

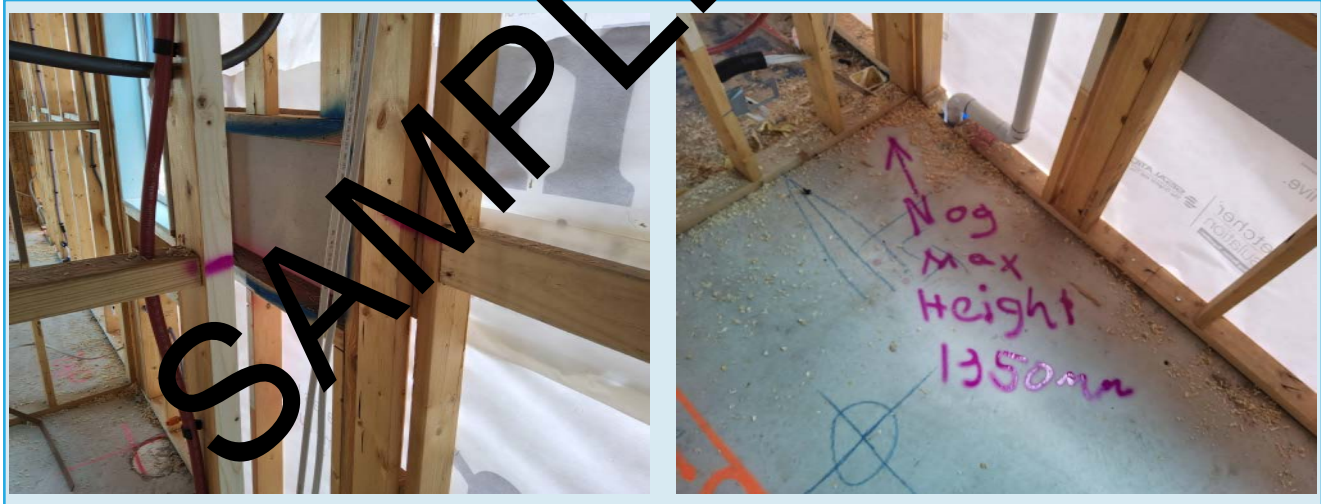
Bedroom 2, front elevation right hand side, it is noted that there appears to be a nagging missing, the maximum height for nagging is 1350mm.

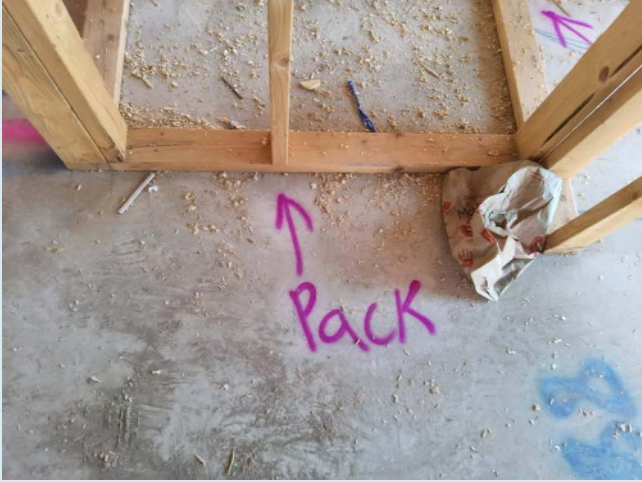
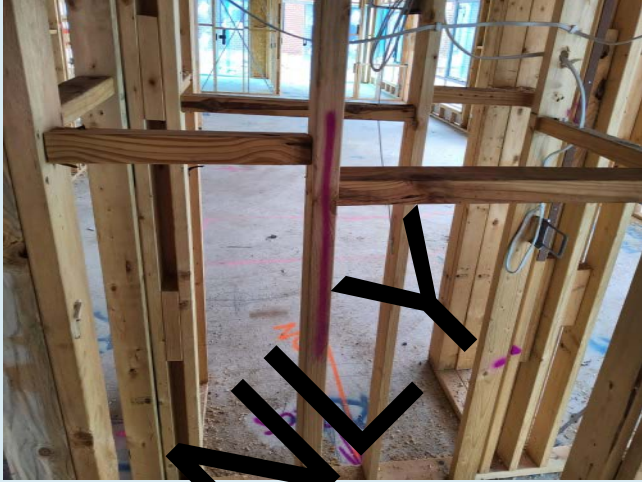
Internal of house inspection	
Minor and/or Major Defect	Internal Walls
Comments	
Passage leading to the laundry, rear elevation, it is noted that the wall requires straightening.

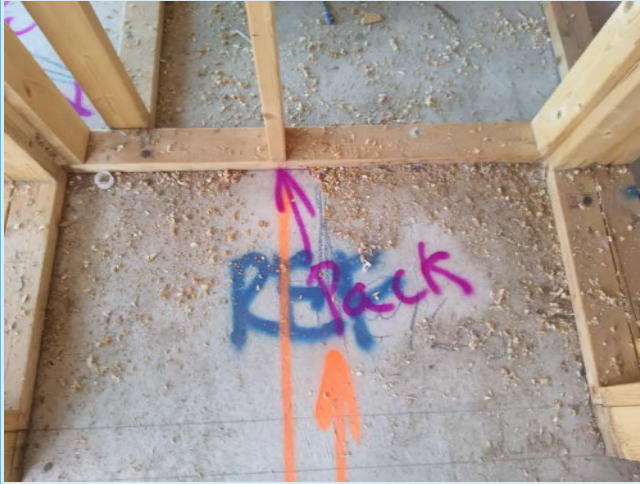
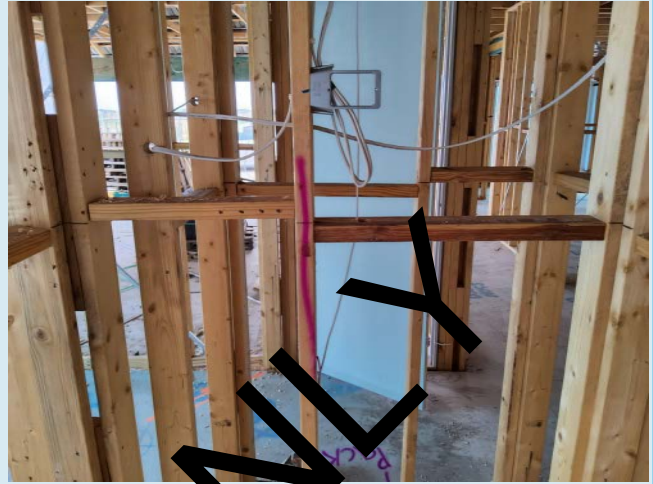
Internal of house inspection	
Minor and/or Major Defect	Internal Walls
<b>Comments</b>	
Fridge space, it is noted that the wall requires straightening.

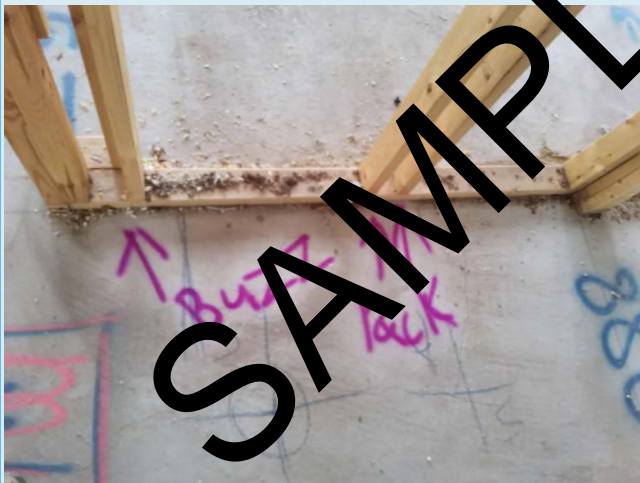
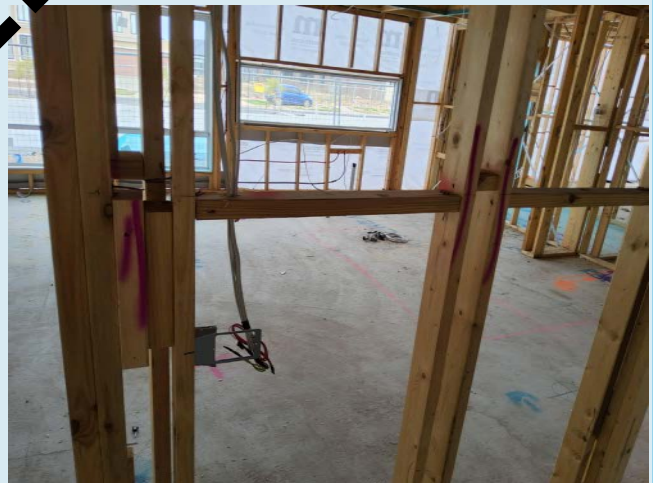
Internal of house inspection	
Minor and/or Major Defect	Internal Walls
<b>Comments</b>	
Passage leading to bedroom 2, right elevation, right hand side, it is noted that the wall requires straightening.

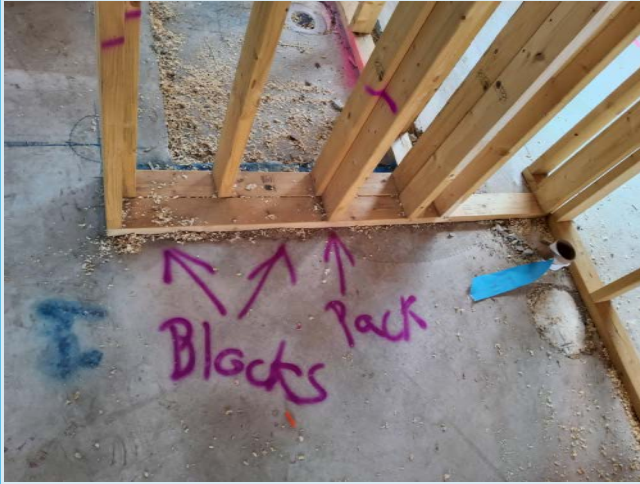
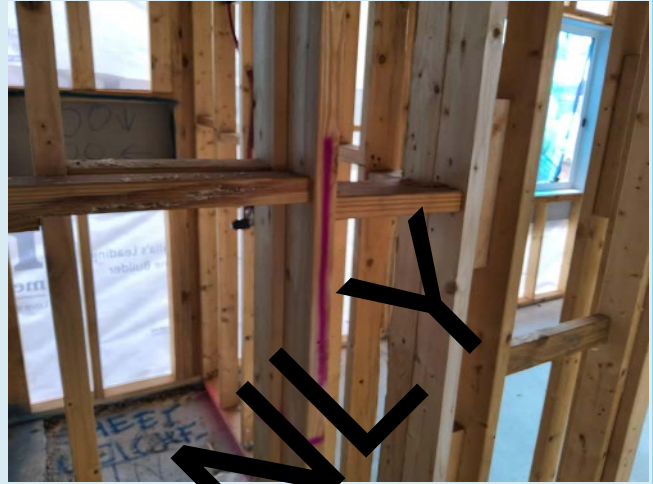
Internal of house inspection	
Minor and/or Major Defect	Internal Walls
Comments	
Bathroom, left elevation WC area, it is noted that the wall requires straightening.

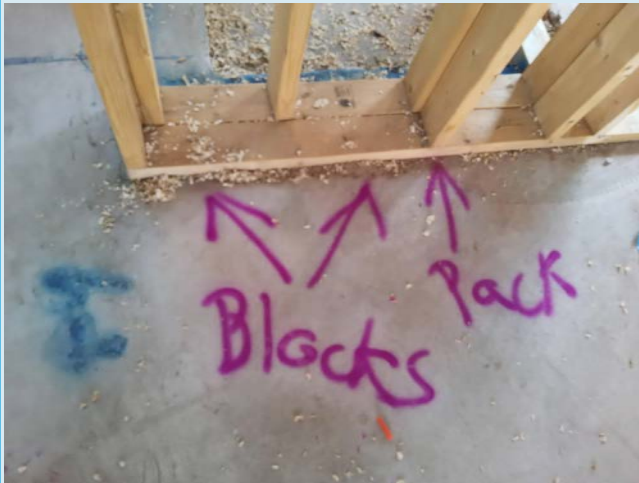
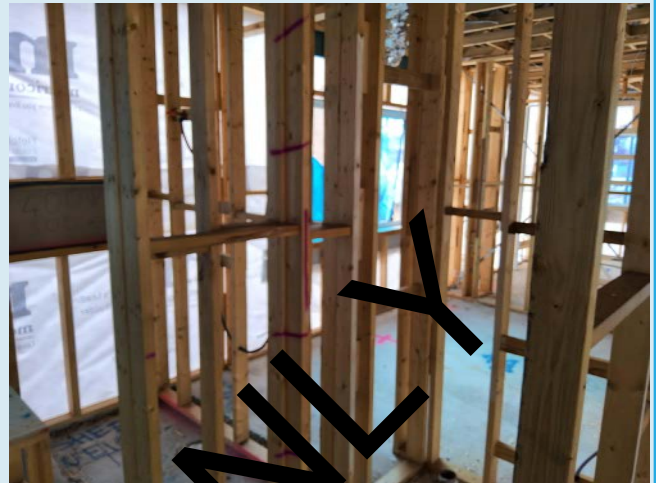
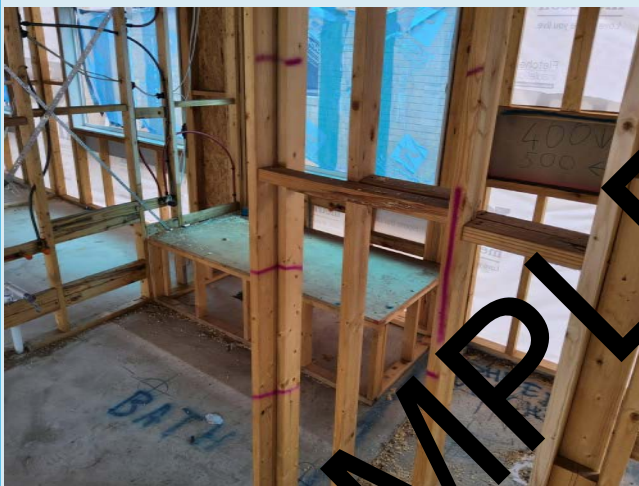
Bathroom, blocks required for double stud walls.

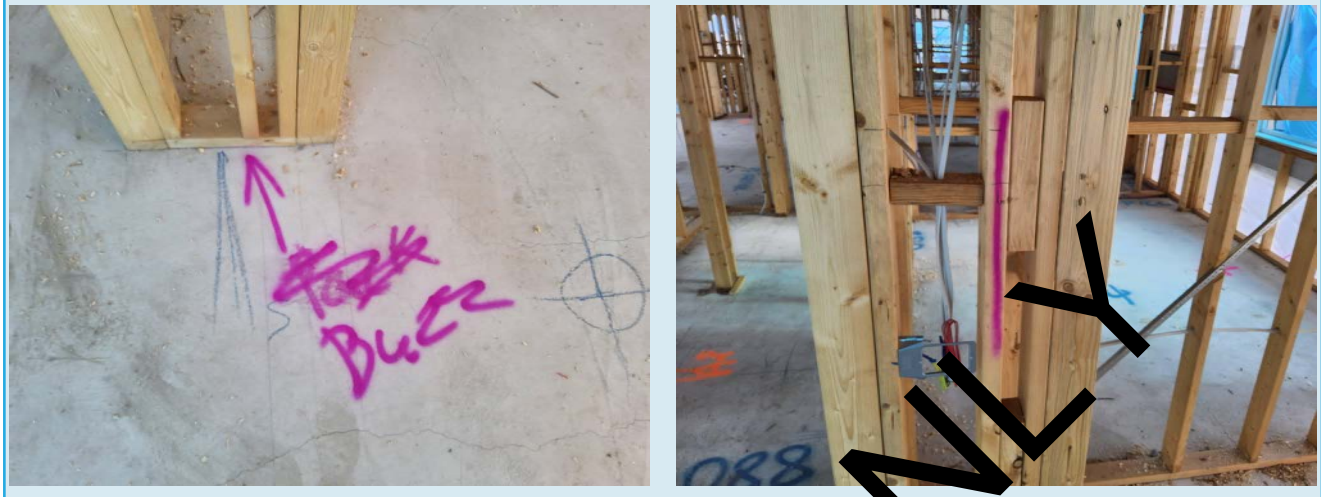
Bedroom 1, front elevation right hand side, it is noted that the wall requires straightening.

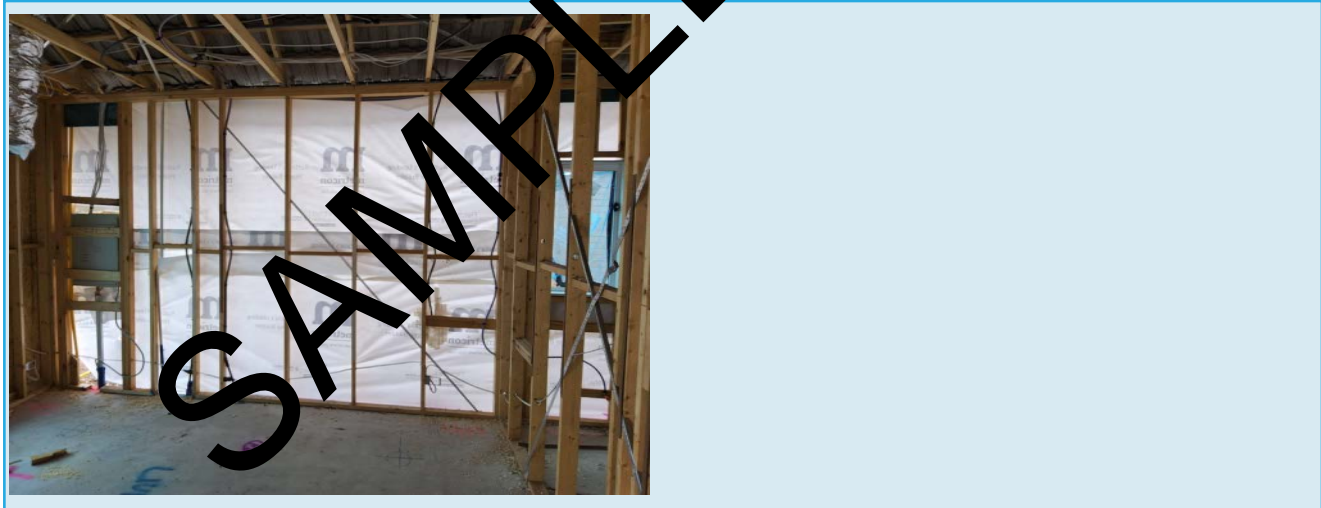
It is noted that the wall insulation was not yet installed at the time of the inspection.
